Matsusaka Castle Ruins

松坂城跡

GENERAL INFO

STONE WALLS (Ishigaki)

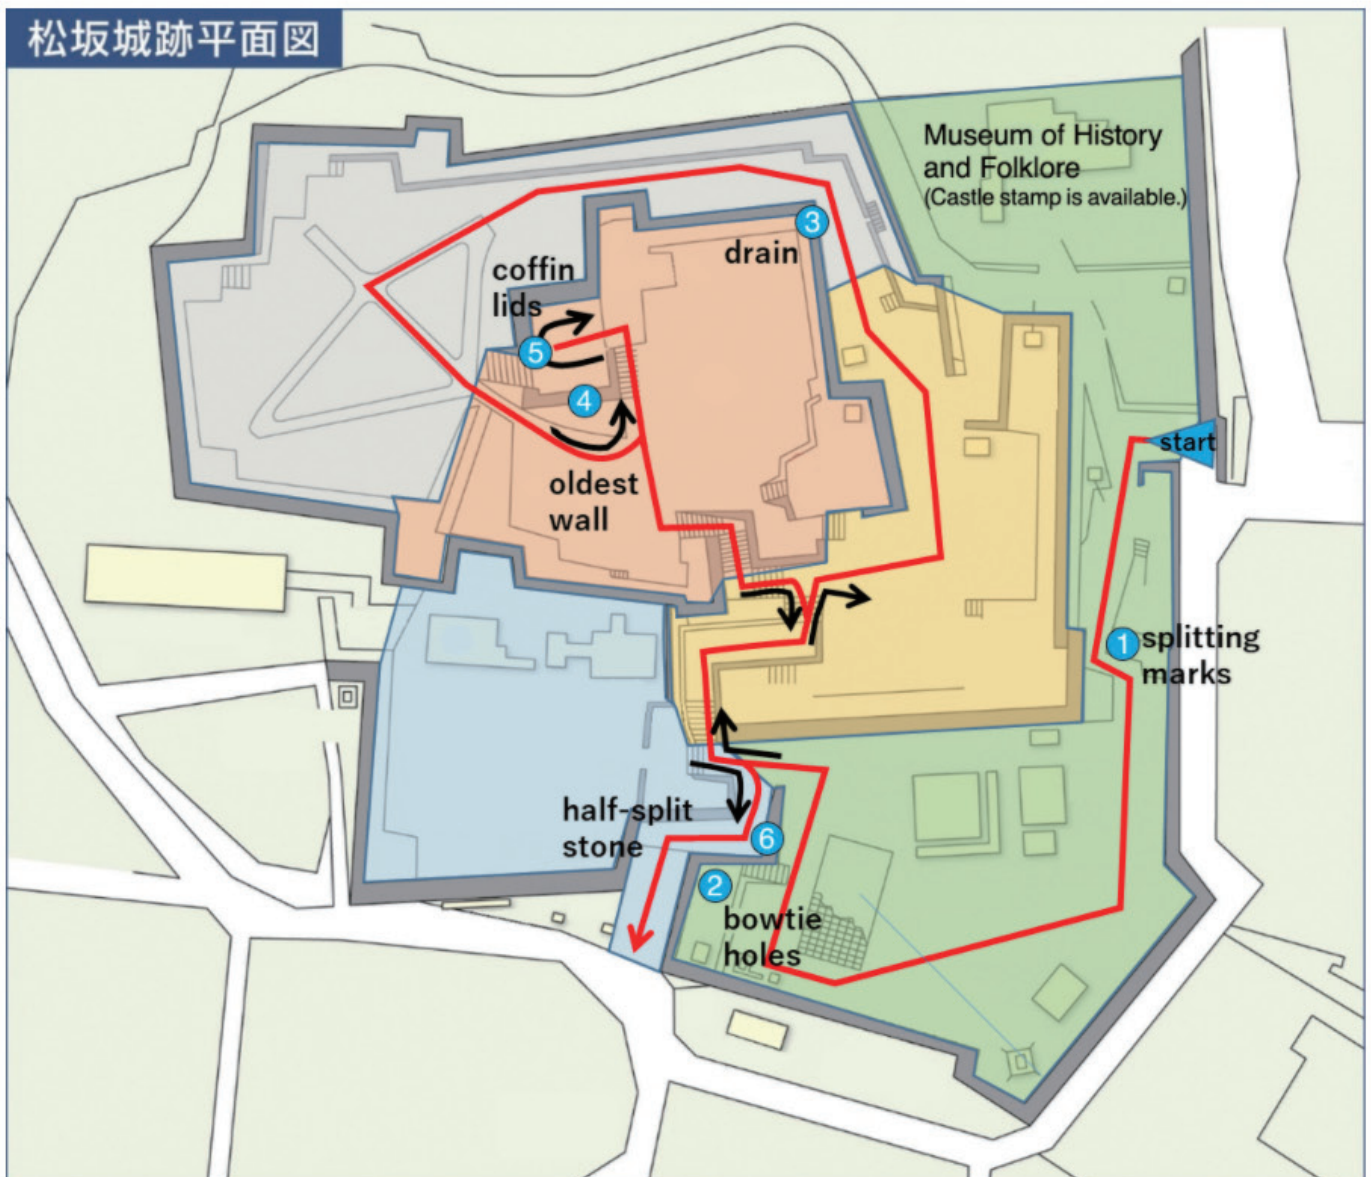
MAP AND GUIDE

Ninomaru	Had a building for important guests and for administration. Now has a large wisteria trellis in the south and history and folklore museum in the north.
Honmaru (Lower)	Had three watchtowers in the north, east and south corners.
Kitaimaru	Had watchtowers at every corner. Now a garden of plum and other trees.
Honmaru (Upper)	The highest level of the castle, where the main castle tower used to stand. Had two watchtowers in the north and east corners, and a large living quarters.
Inkyomaru	Had two warehouses, a granary, and a treasury.

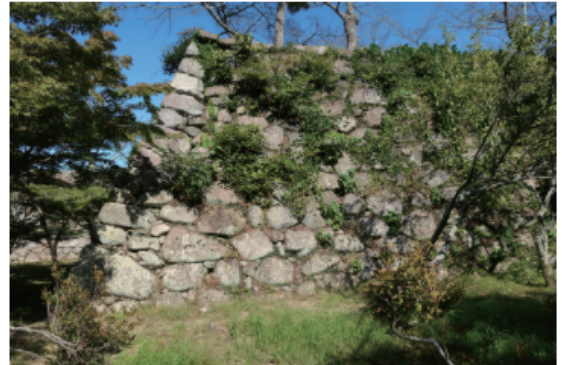
Nozura-zumi

The original style of Matsusaka Castle, with natural stones taken from the nearby river. It is the oldest technique.

- Natural shapes
- Wide gaps
- Irregular

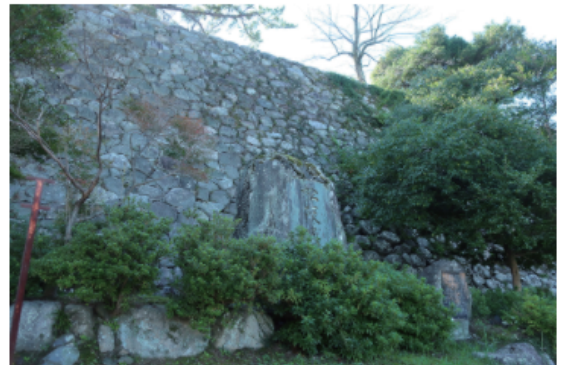
Uchikomi-hagi

A newer technique where the stones are chiseled or hammered into shape. The gap between stones is smaller than in *nozura-zumi*. You can see this technique where repairs were made.

- Angular shapes
- Smaller gaps
- Tool marks

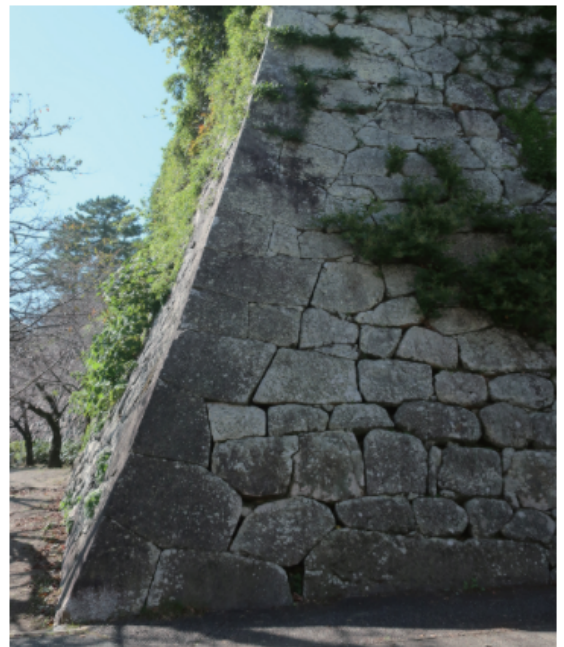
Sangi-zumi

Rectangular blocks are used to form the corners of the walls. You can see this technique where repairs were made.

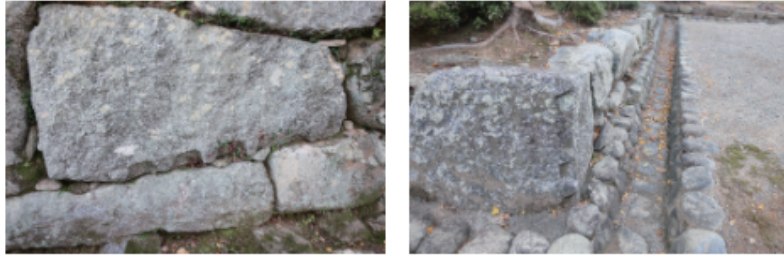
① Marks from splitting stones

These stones were split from larger rocks by driving wedges into them. Many examples throughout castle.

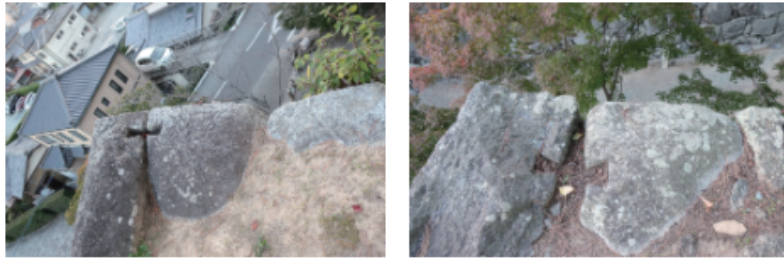
② Bowtie-shaped holes

A kind of staple was inserted to hold the stones together.

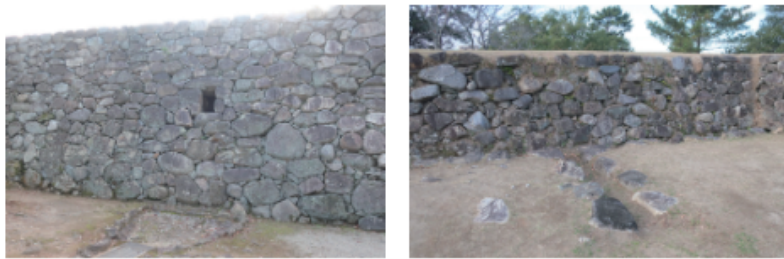
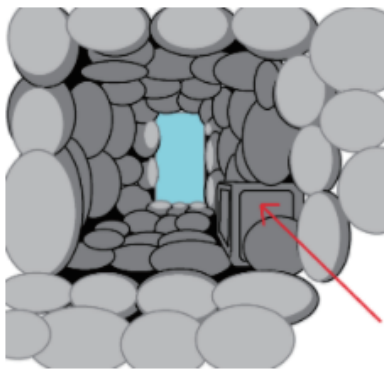
③ Drain with stone from temple

Look from both sides to understand the design. If you look inside the drain from the upper level, you can see a cube-shaped stone on the right side. It is thought to be reused from a temple sculpture.

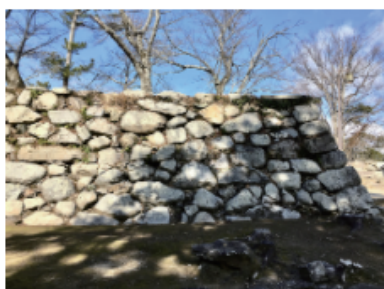
④ Oldest stone wall

This wall is made of all natural stones, and the corner is a primitive design, so it is thought to be the oldest. The top of the wall has been repaired, though.

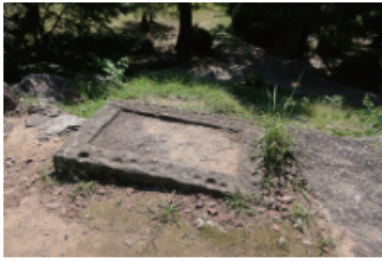
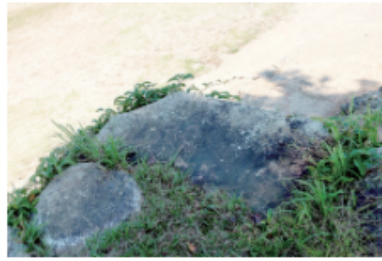
5 Stone coffin lids

Taken from ancient tombs and reused as foundations for the castle tower. Matsusaka Castle was built in a hurry—in only 3 years—so stones were taken from various places.

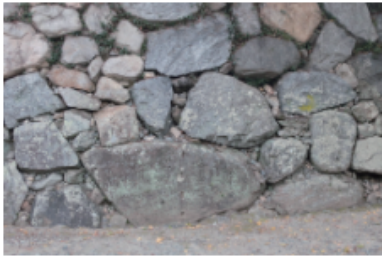
6 Half-split stone

It looks like workers started to split the stone with wedges, but gave up and used the stone as-is.
